Case Studies of Zebra Mussel Control at Raw Water Intakes

Presenter: Mark Hardie, P.E. Senior Project Manager HR Green, Inc.

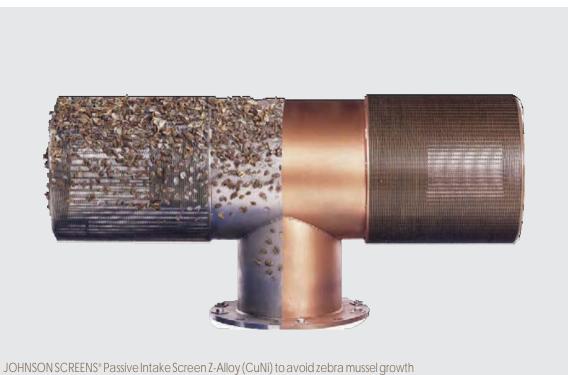
Water Systems – Raw Water Intakes o Intake screens

- Copper
- o Brass
- o Galvanized steel
- o Z-Alloy ™ material

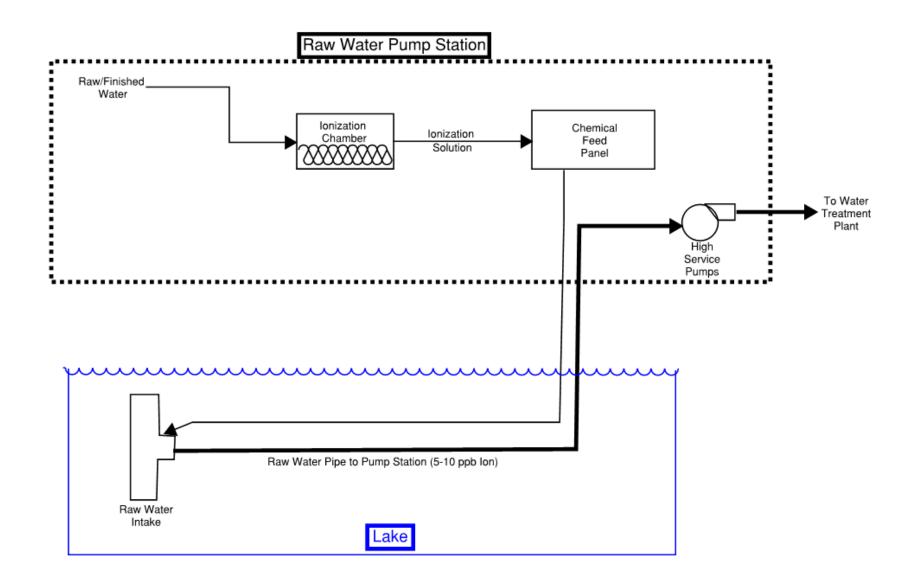
- Generation equipment produces copper ion solution
- Equipment inputs:
 - Raw or Finished carrier water stream (10-20 gallons per minute)
 - Electrical current (5A, 120VAC)
 - Copper anodes (replaceable)
 - Control inputs
- Equipment outputs:
 - Copper ion solution in carrier water stream, 1 part per million (ppm) concentration
- Copper Ion Solution injected into bulk raw water flowstream, blending down total effective copper concentration to 5-10 ppb

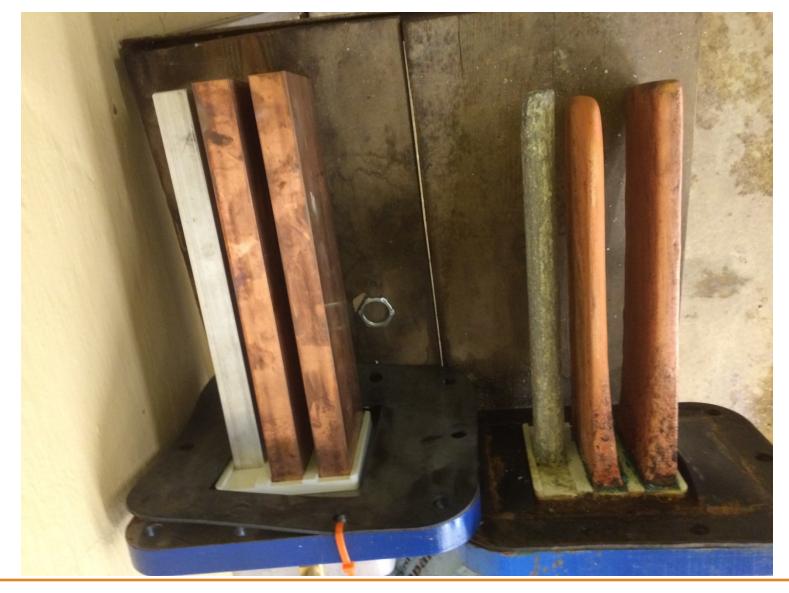
ORIGINAL ANODES (22 MONTHS)

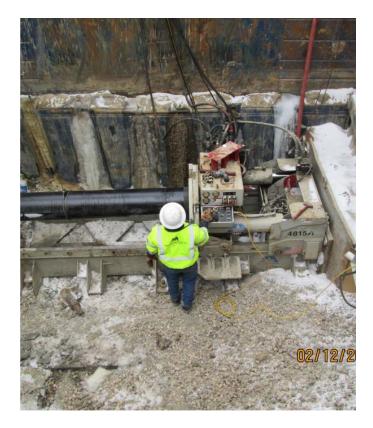
Installing the new 16-inch pipe from shore

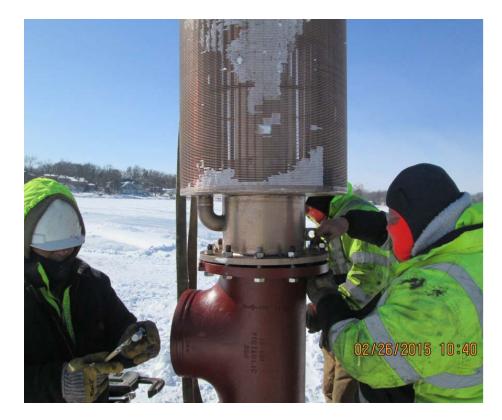
Assembling new 16-inch intake screen

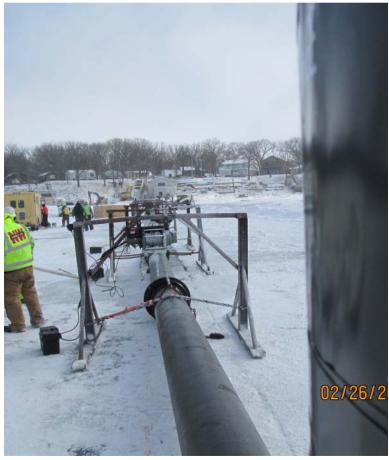
Laying out intake piping on frozen lake

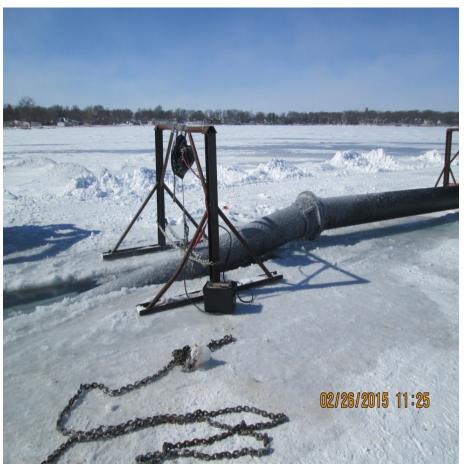
Lowering intake pipe through ice

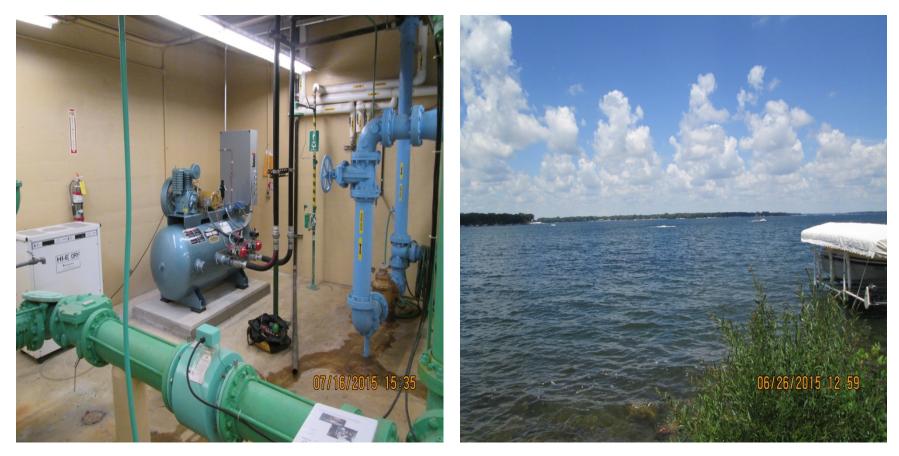
Hydroburst tank inside Pumphouse Building

Hydroburst backwash of intake screen

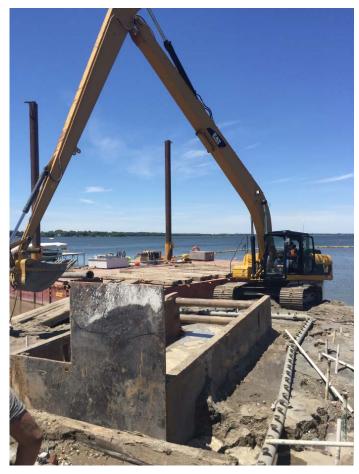
Dewatering at shore

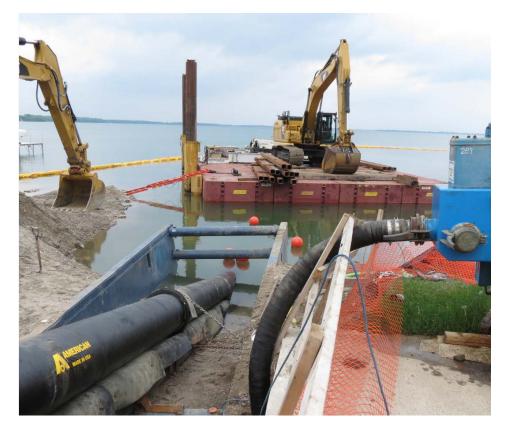
Initial setup for installation of intake line

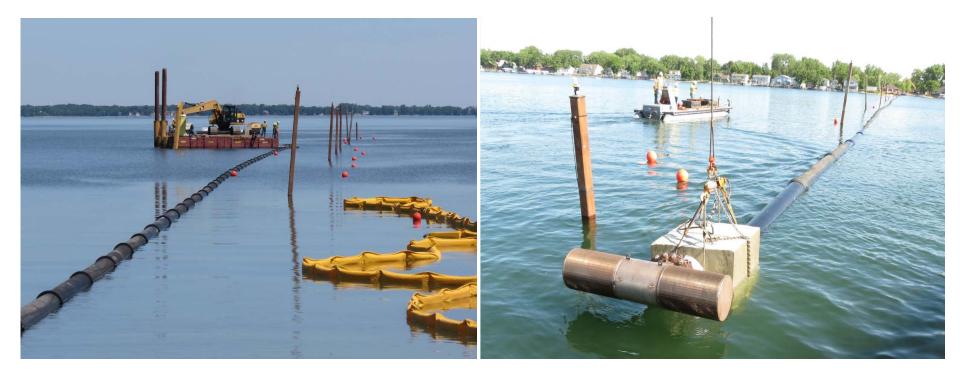
Installation of intake line

Installation of intake screen

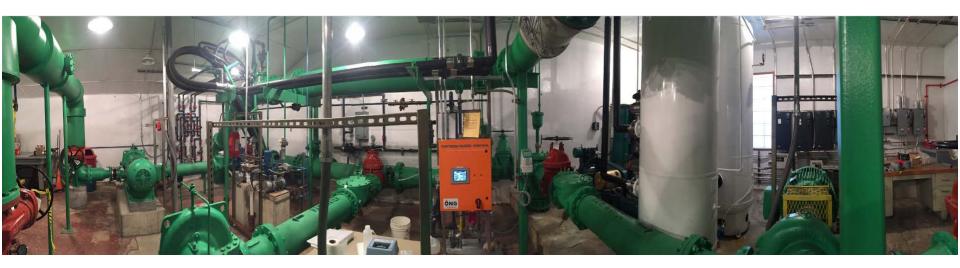
Panoramic of inside pump station
