SOUTH DAKOTA GAME, FISH and PARKS

Role of Inter-agency Cooperation in AIS Prevention

Belle Fourche Dredging Project

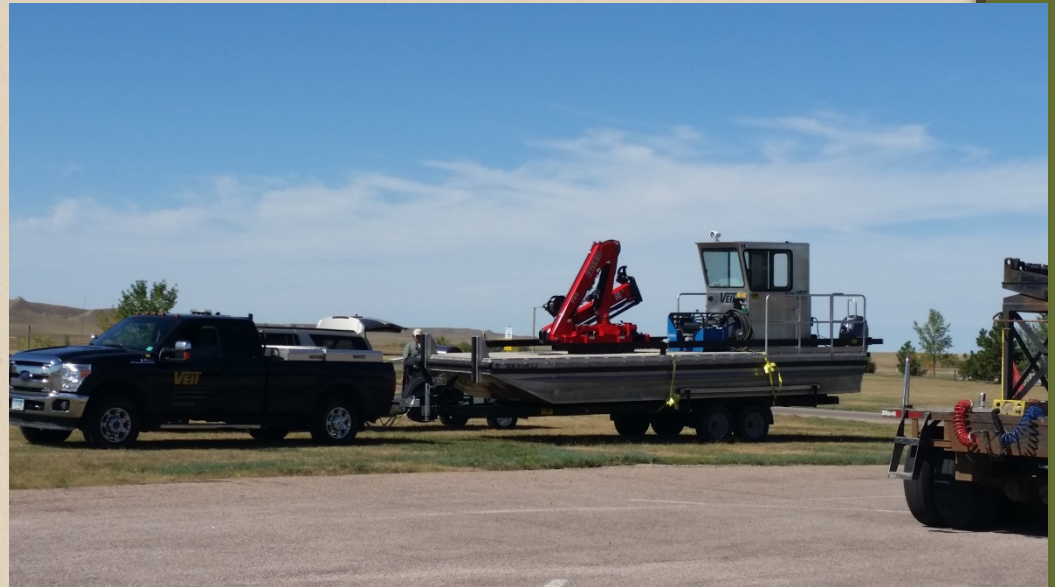
Inspection Results

- Zebra Mussels found on:
 - All barges
 - Pins
 - Pump housing
- Additional violations
 - Standing water found in three barges
 - Support boats
 - Plugs in place
 - Water in bilges
